Cavity protection against rust

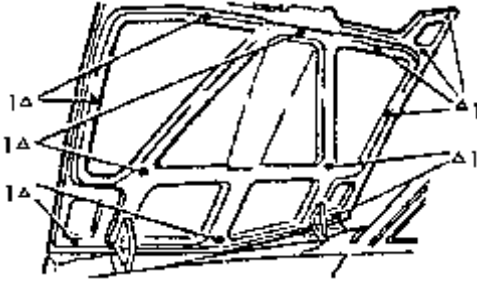
1 Front boot lid

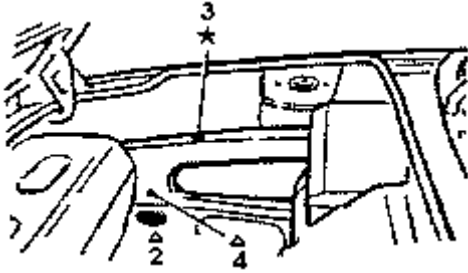
2 Bottom in boot

Temporary remove plugs

3 Longitudinal members, front top

4 Longitudinal members, front lower

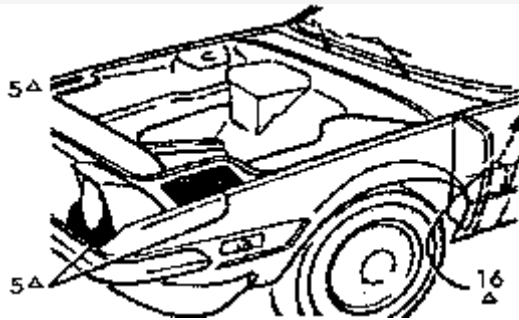
5 Front wings, front part

Temporary remove plugs, open headlamp pods

16 Front wings, rear part

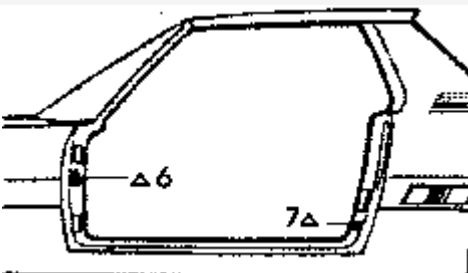
6 A-stolpe

Temporary remove plugs

7 Rear wings, front part

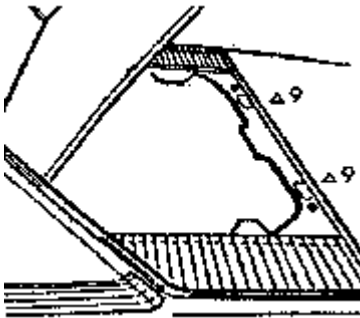
8 Doors

Temporary remove plugs

9 Crossmember in top of engine compartment

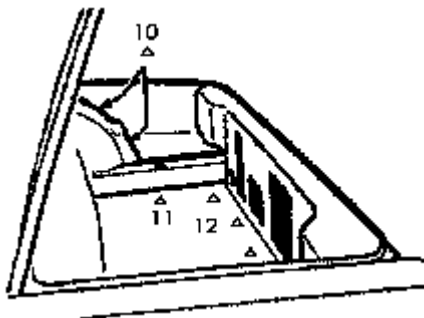
10 Rear wings, rear part

11 Longitudinal members, rear

Temporary remove plugs

12 Rear panel

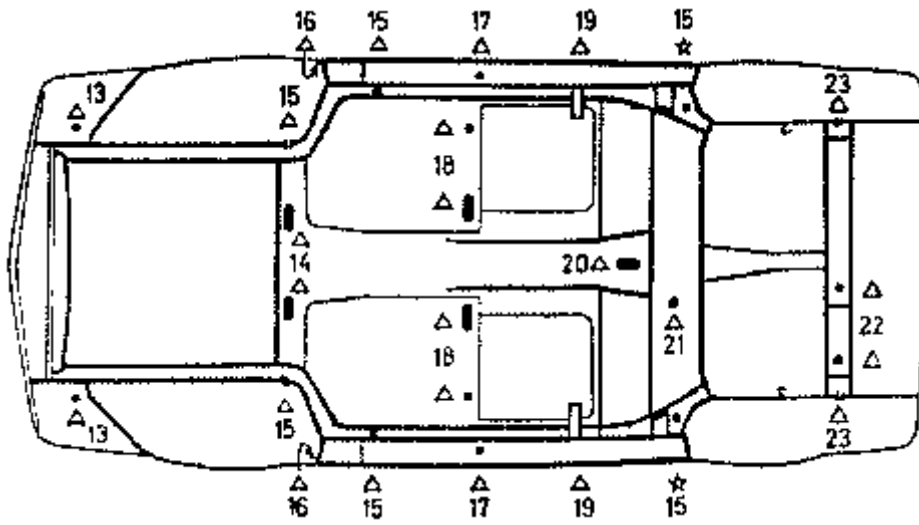
13 Front wings, front part

14 Crossmember in cabin floor front

Temporary remove plugs

15 Door sill middle section

Temporary remove plugs, Drill hole if necessary

16 Front wings, rear part

17 Door sill outer section

18 Crossmember in floor

19 Jack consoles

20 Center tunnel behind fueltank

21 Crossmember middle

22 Rear crossmember

23 Reinforcements
